# Biological and Water Quality Study of Mill Creek and Tributaries

Butler and Hamilton Counties, Ohio

**Volume 1**

**OEPA Technical Report SWS/1993-12-9**

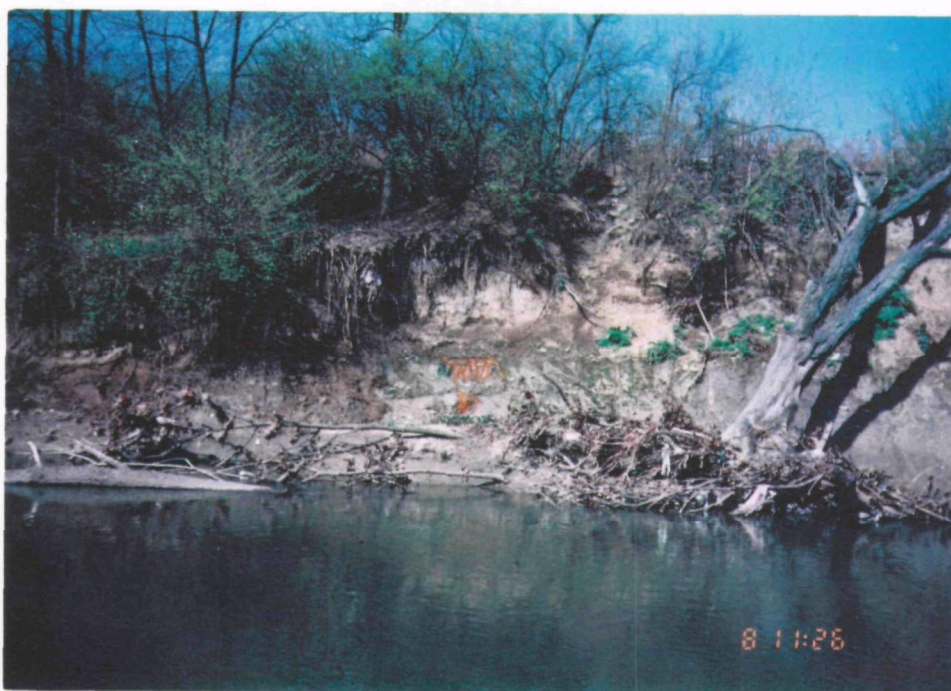
**Plate 1.** Seeps emanating from the banks of Mill Creek mainstem from potential hazardous waste sources. *Top Photo:* Multi-colored seep staining the bank of Mill Creek near Pristine/Cincinnati Drum property near Reading. *Bottom Photo:* Seep staining the bank of Mill Creek at the Ridgewood Arsenal site near Seymour Avenue in Cincinnati.

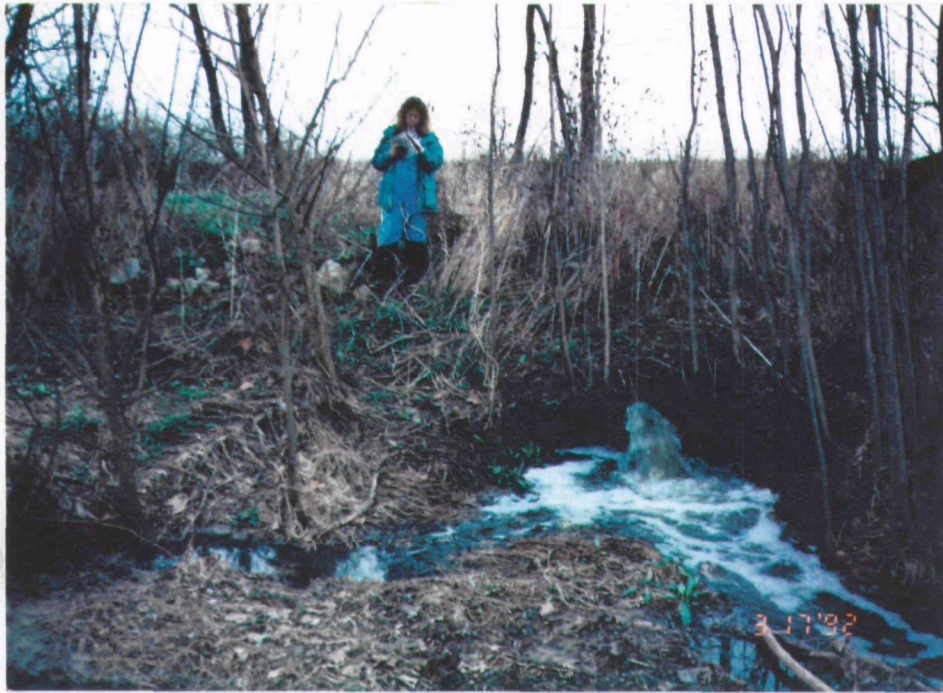
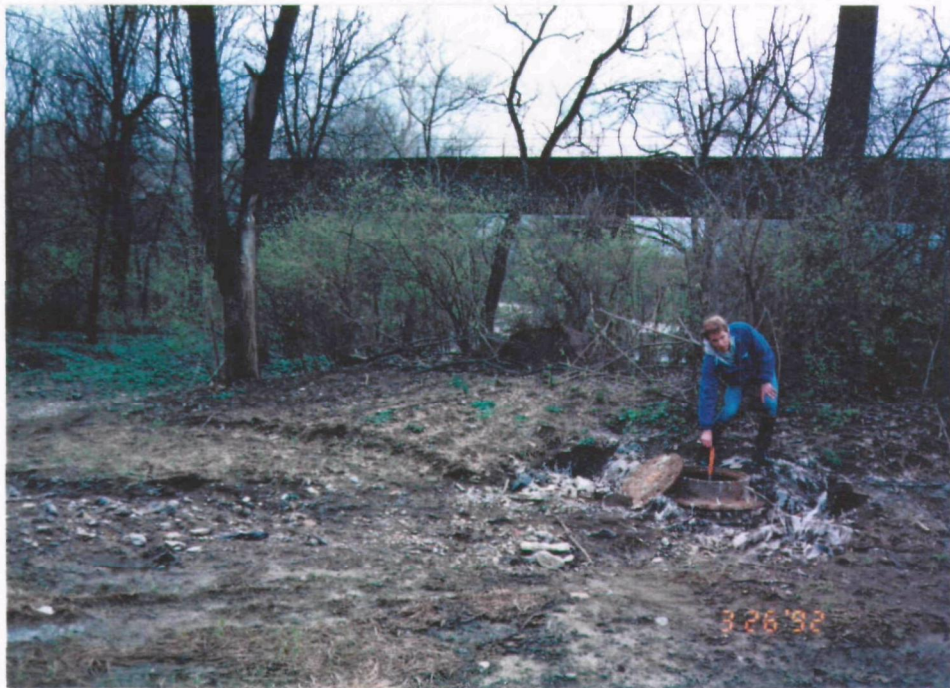
**Plate 2.** Sewer overflows in the Mill Creek basin. *Top Photo:* Raw sewage discharge to Mill Creek from broken sewer line cleanout at Windisch Road. *Bottom Photo:* Sewage solids trail leading to Mill Creek from an open manhole at the confluence of Mill Creek and Cooper Creek.

- Exceedences of the Primary Contact Recreational Use Criteria for fecal coliform and *E. coli* existed at all sites from river mile 1.85 to 0.01 (>20000/100ml was the highest documented). The most elevated levels were documented at river mile 0.01, just downstream from a sewer line crossing in the stream bed. Investigation during October 1993 by the Hamilton County Metropolitan Sewer District discovered the stream had eroded the bed under the sewer line causing leakage of sewage into East Fork Mill Creek. The Metropolitan Sewer District repaired the sewer line during the Fall of 1993.

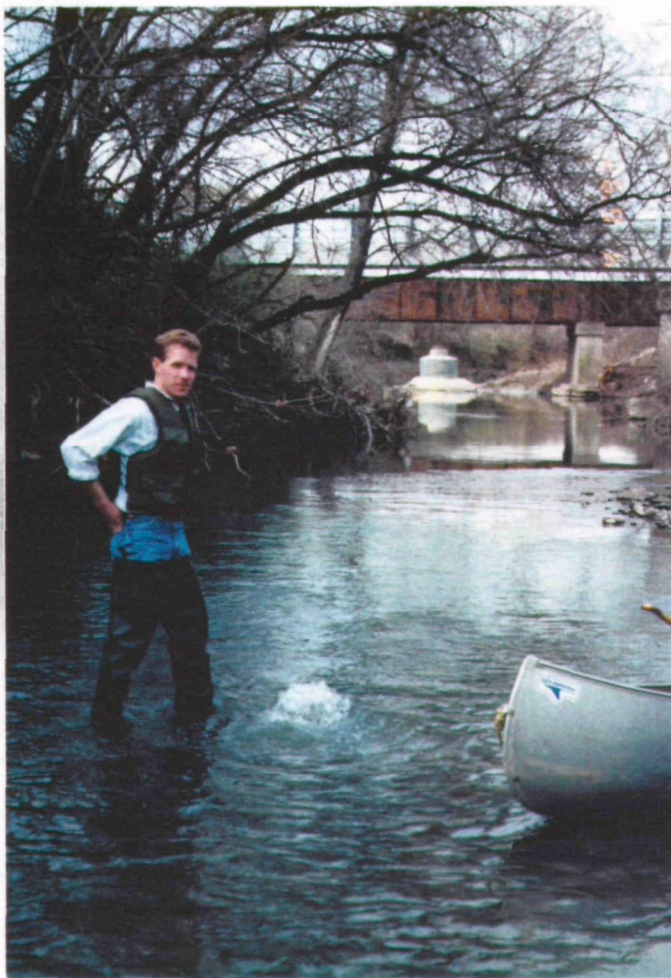
**Plate 3.** Sewer manhole located in the stream bed of Mill Creek discharging sewage into the stream downstream of the G.E. tributary.

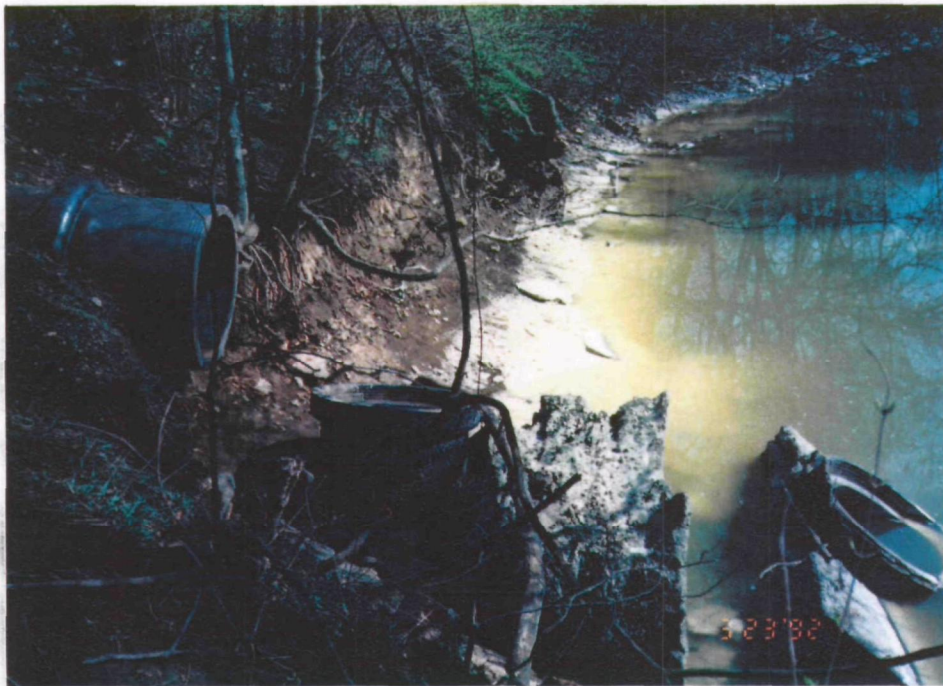
**Plate 4.** Remains of lime sludge from the City of Wyoming Water Treatment Plant and sewage overflows evident in West Fork Mill Creek near Gardner Park in Lockland.

- The quality of macroinvertebrate communities in West Fork Mill Creek ranged from fair to poor. The lower performance rating occurred at river mile 2.0, downstream from an observed septic discharge and evident lime sludge from the water treatment plant of the Village of Wyoming. Trash and rubbish also was present at this site. Some improvement in the invertebrate community was observed at sites farther downstream. All sampling locations for fish communities documented populations indicative of poor water quality.

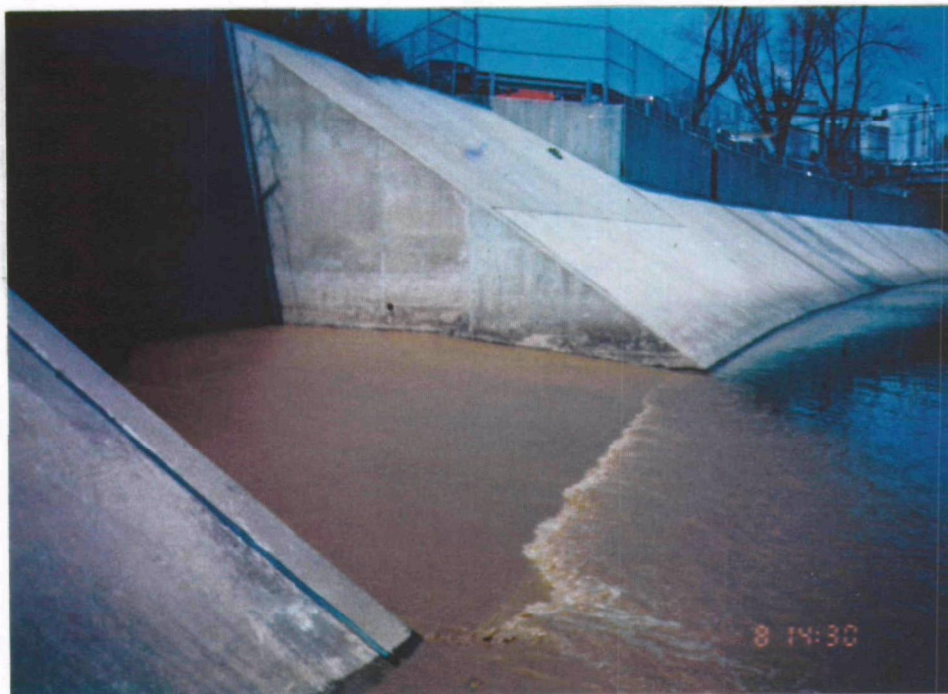
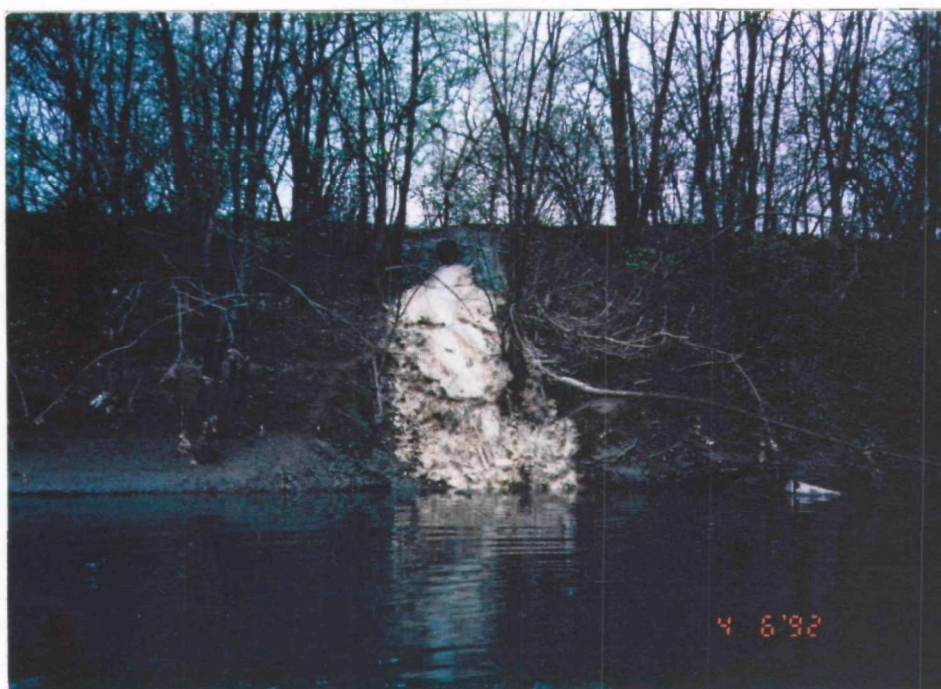
**Plate 5.** Discharges to Mill Creek from industrial activities. *Top Photo:* Silt laden discharge from Rack Sand and Gravel operation to Mill Creek in the concrete channel area. *Bottom Photo:* Cement discharge to Mill Creek from Plainville Concrete upstream from Clark Road. The concrete discharge had dried at the time of this photo.

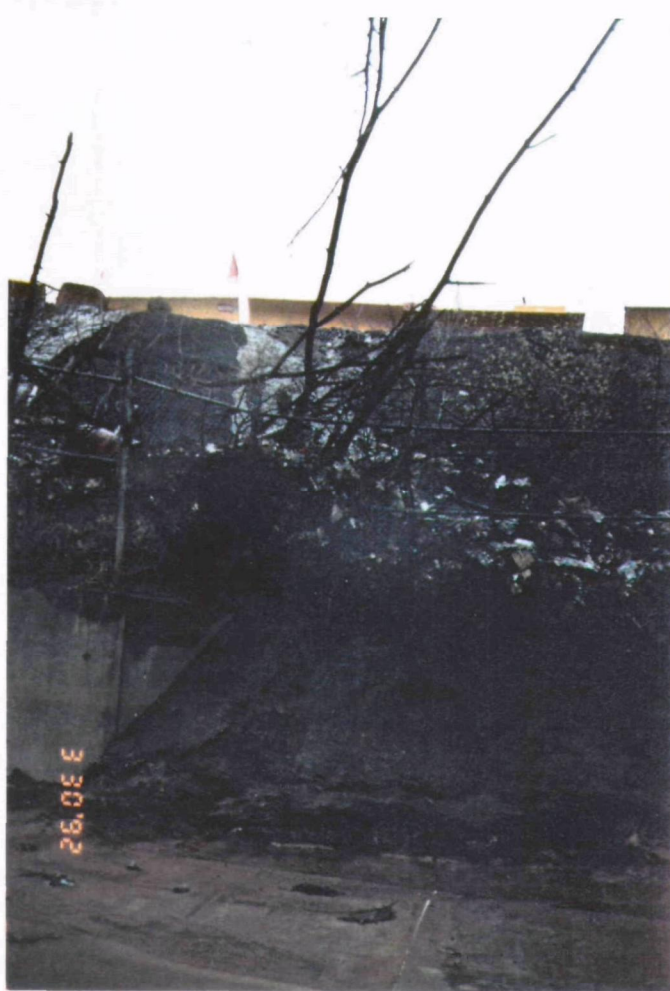
**Plate 6.** Asphalt, sealant and trash piled along the bank and entering the concrete channel of West Fork at the City of Cincinnati asphalt plant.

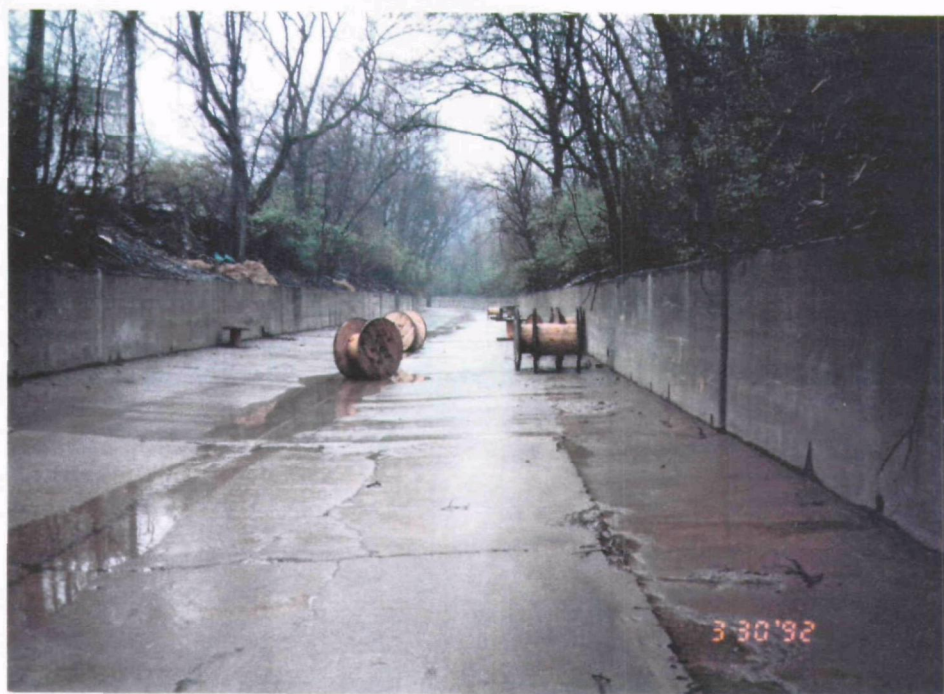
**Plate 7.** Large cable spools dumped into the channelized section of West Fork from a near by company.

- West Fork was neither biologically nor chemically assessed during the 1992 survey due to the extent of permanent concrete revetments. It was biologically evaluated during 1991 and found to be severely degraded (Ohio EPA 1992). Not only has the stream channel been permanently concreted through the jurisdictional region of the City of Cincinnati, but the normal flow of the stream has been diverted to enter into the combined sewer system and is directed to the MSD Mill Creek WWTP. During field reconnaissance prior to the survey, it was noted that the City of Cincinnati asphalt plant has heavily impacted the banks of West Fork near the confluence with Mill Creek by dumping old asphalt, sealant and trash on the right bank of the stream. Most of this material was above the cemented area of the banks. Also noted during reconnaissance was the presence of several huge cable spools which a company near the most downstream railroad crossing had dumped into the stream channel.
